Printed: June,1982 Tested at: Lethbridge ISSN 0383-3445

# **Evaluation Report** 279

# International Harvester Model 445 Baler

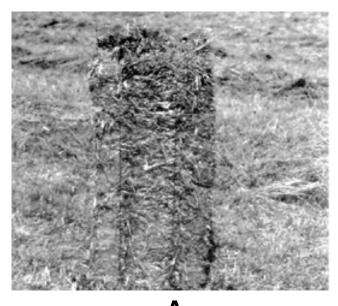
FIGURE 2. Typical Bales: (A) Alfalfa, (B) Bromegrass, (C) Greenfeed, (D) Wheat Straw.

**Bale Quality:** The International Harvester 445 was capable of producing firm durable bales with square ends in most crops (FIGURE 2). Average hay bales weighed 23 to 39 kg (50 to 85 lb), while average straw bales weighed 20 to 27 kg (45 to 60 lb). Average bale density varied from 122 to 234 kg/m<sup>3</sup> (7.6 to 14.6 lb/ft<sup>3</sup>) in hay and from 115 to 161 kg/m<sup>3</sup> (7.2 to 10.0 lb/ft<sup>3</sup>) in straw.
